Fox River

A remedy that works

Sediment Management Work Group Meeting
April 28, 2009

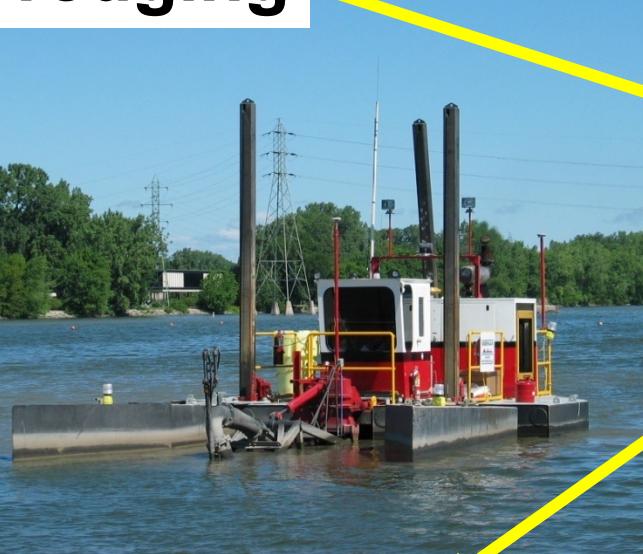
Dredging

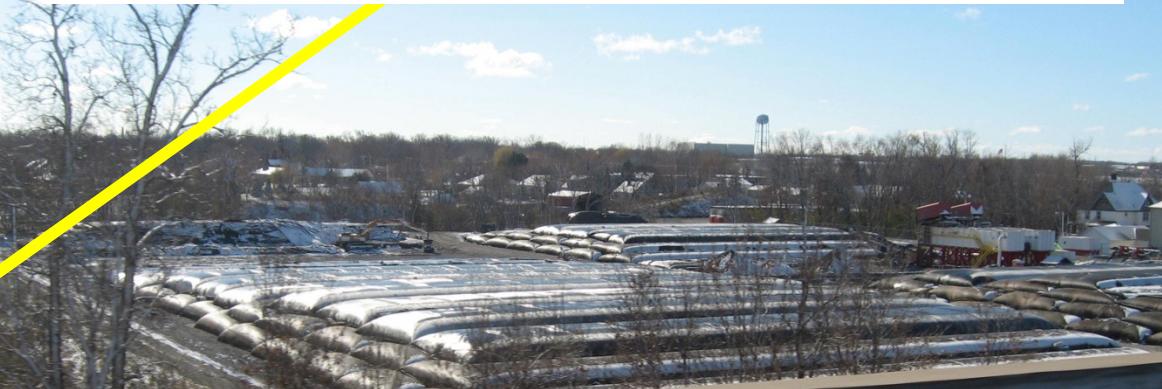
Dewatering (geotextile tubes)

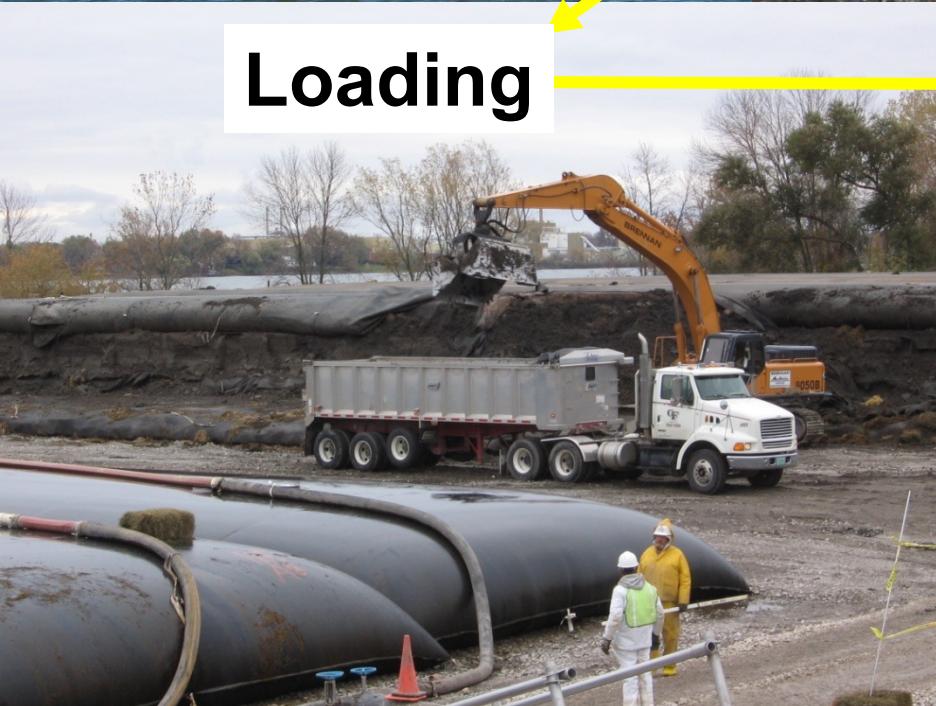
Loading

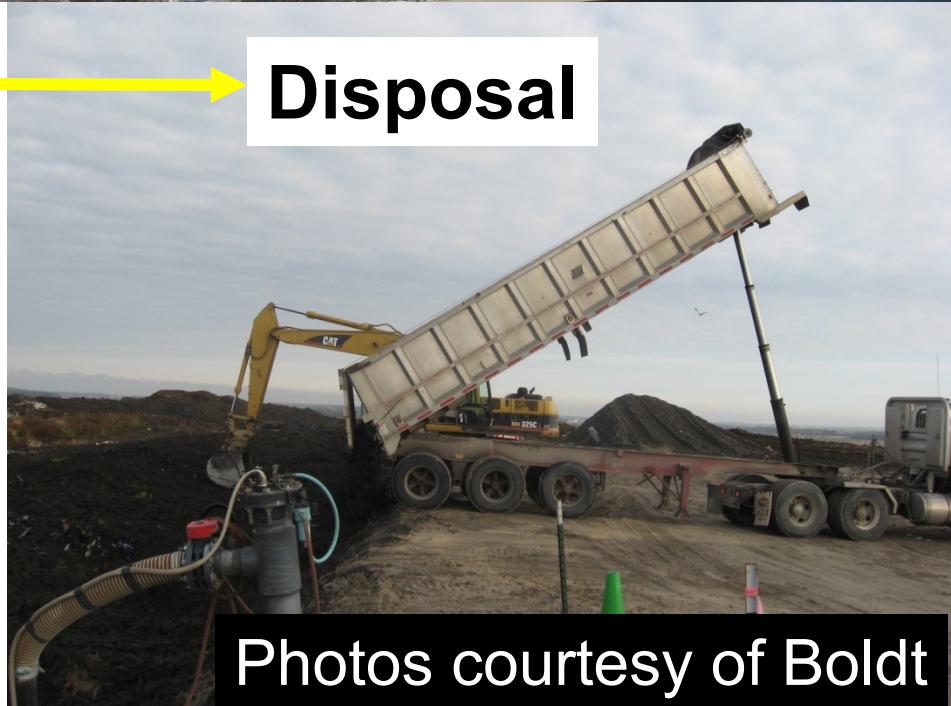
Disposal

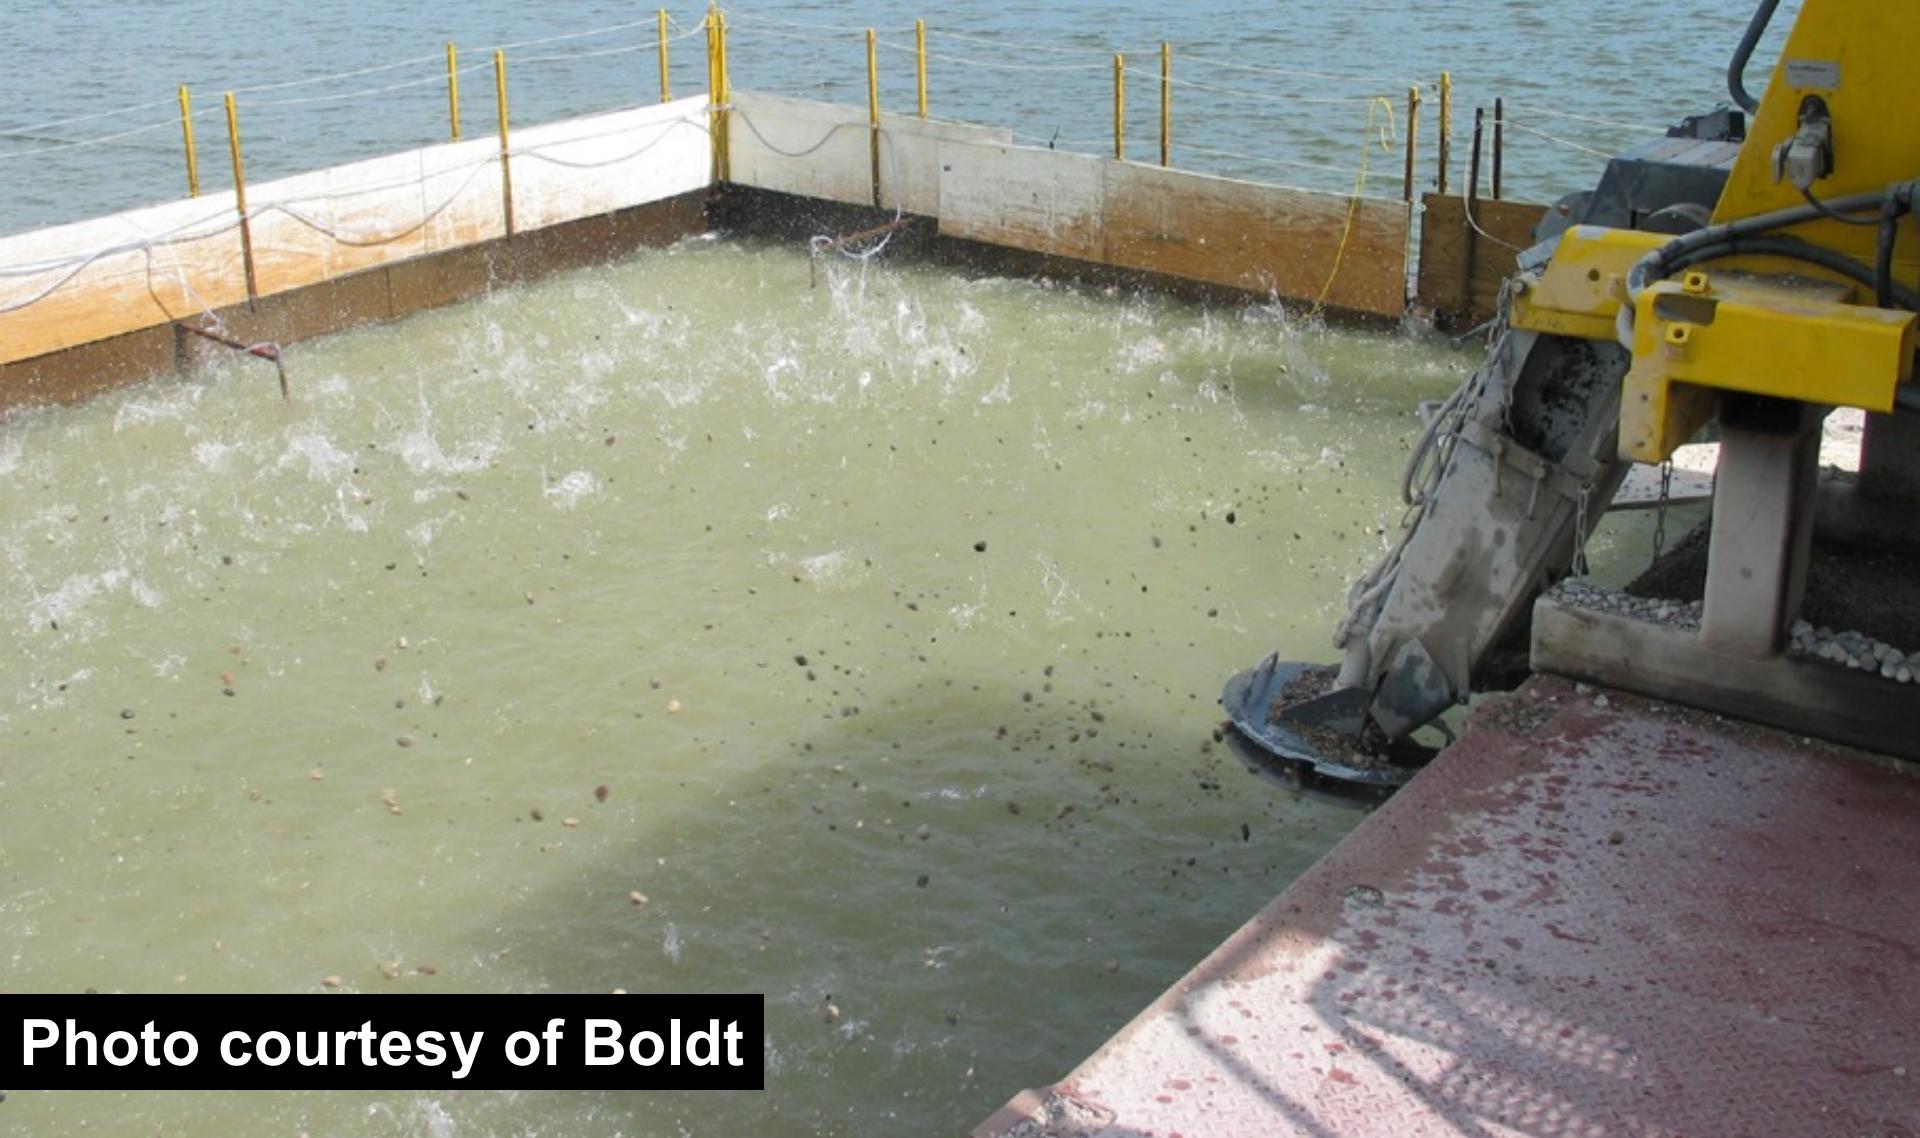
“Throwing stone” (cap armor stone)

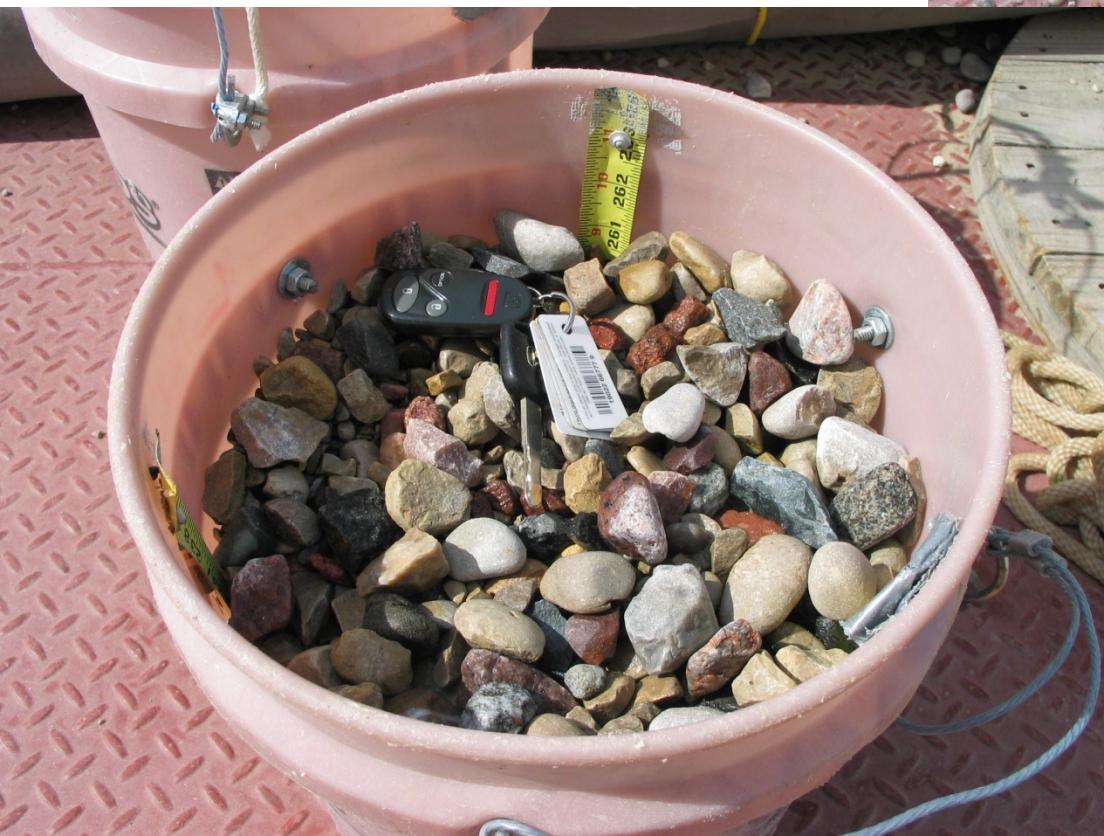
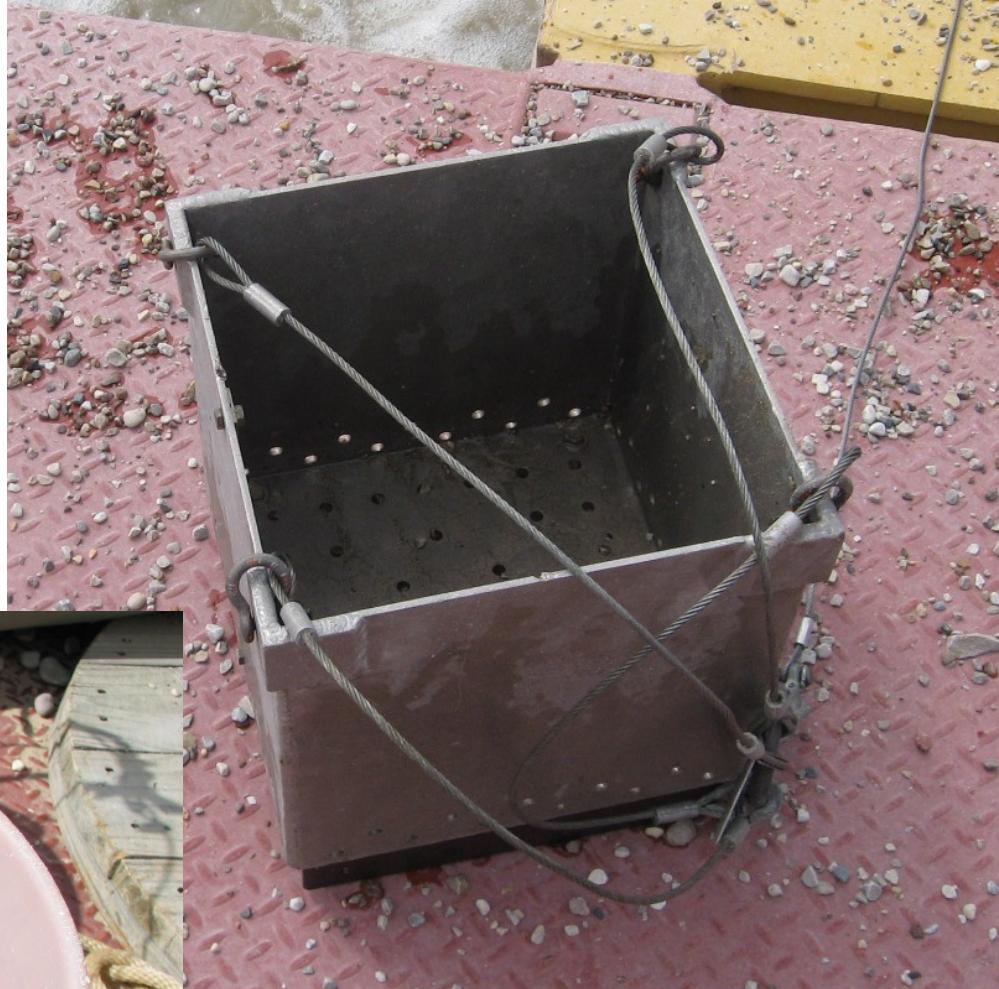
Cap armor stone thickness measurement devices

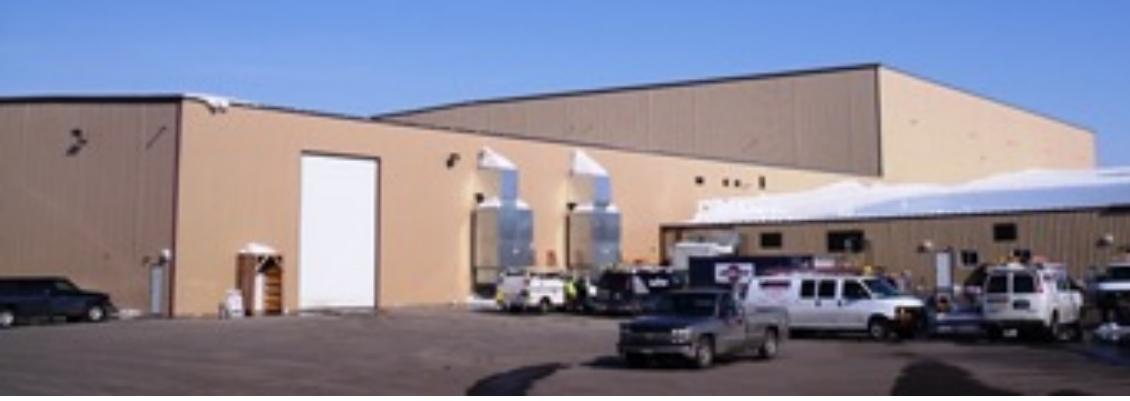
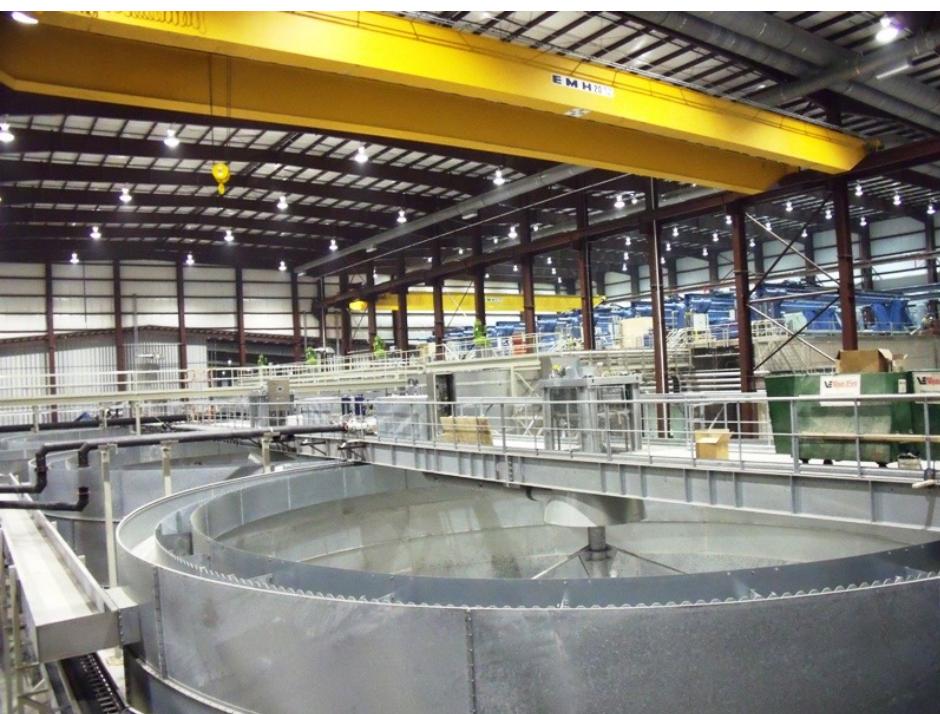
Dewatering and water treatment facility

Pre-thickener

Plate and frame presses

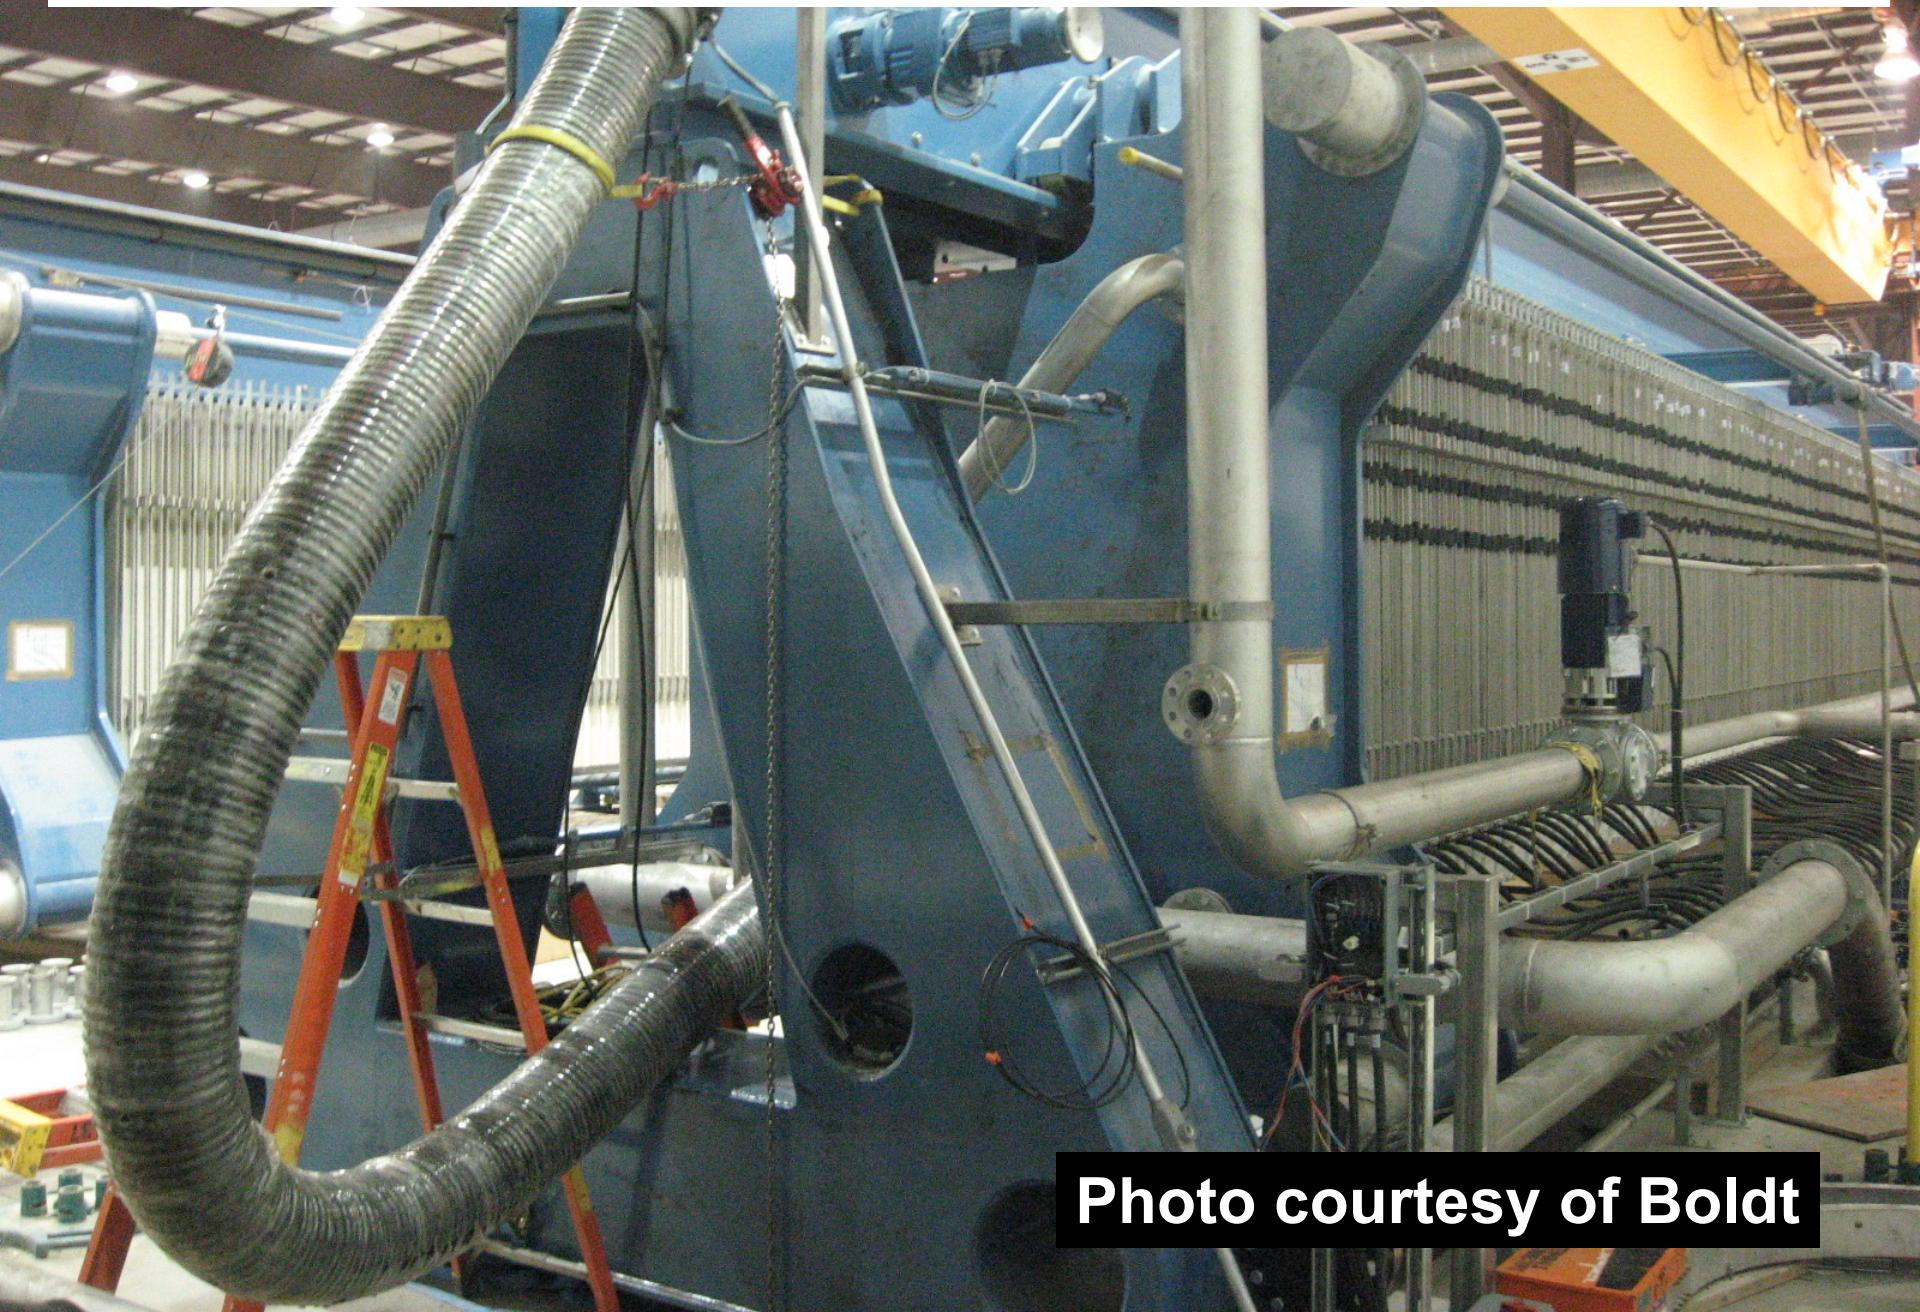
Plate and frame presses – OU 2 - 5

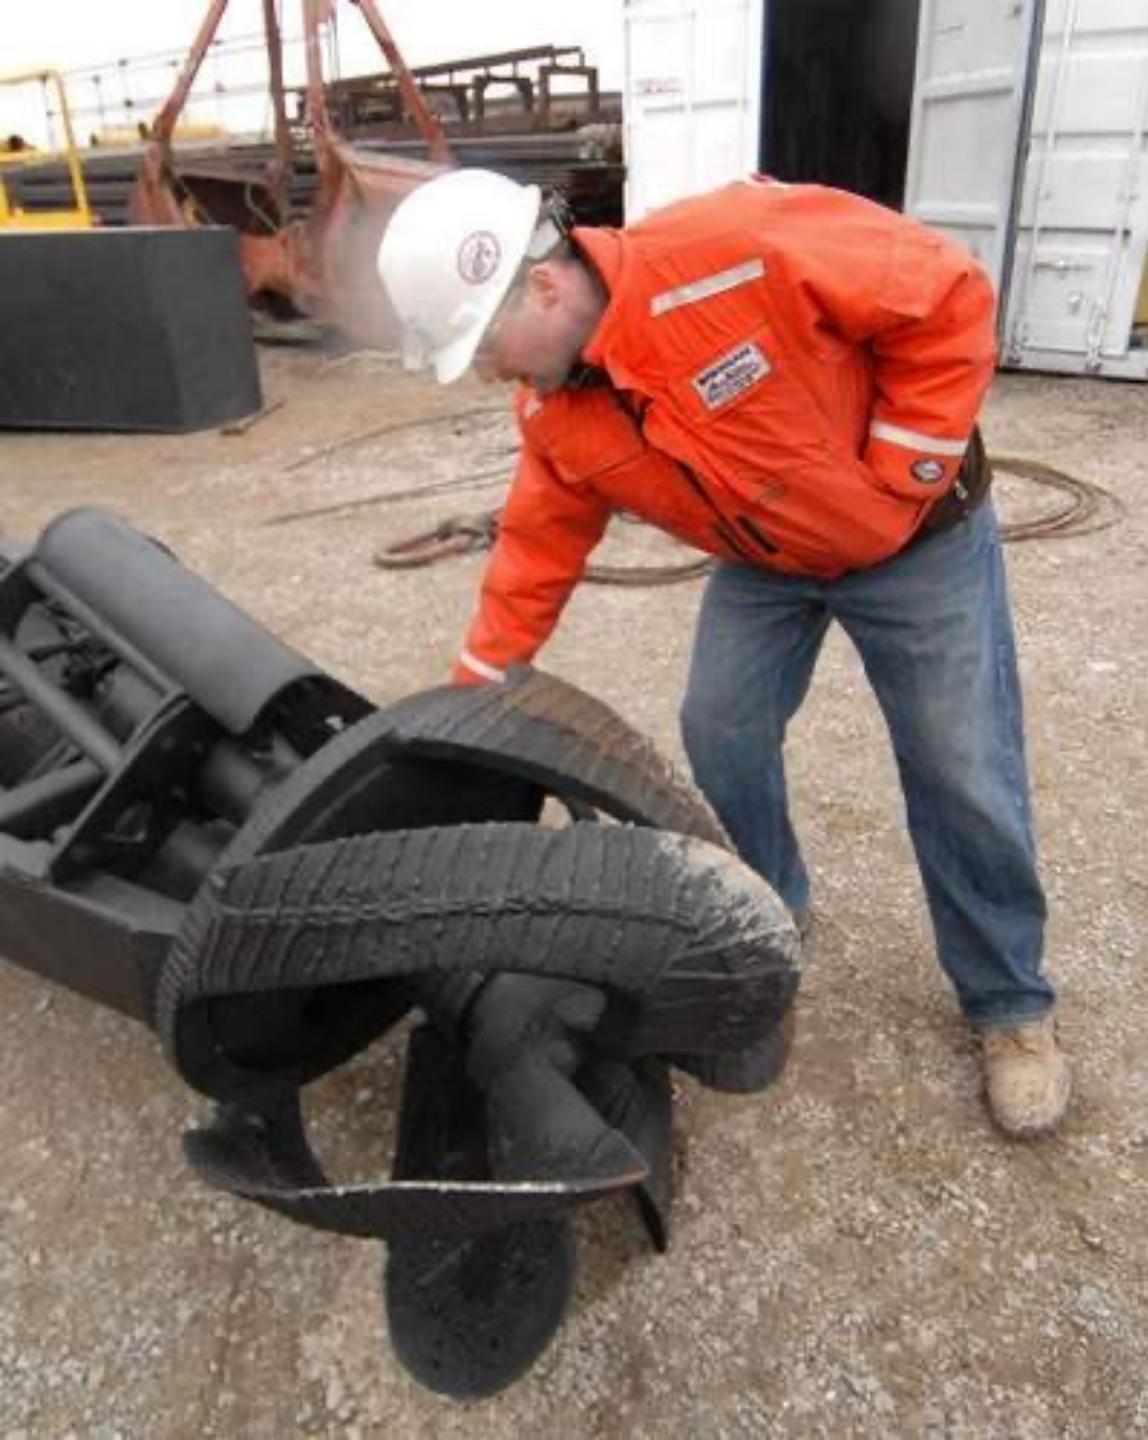
Dredge cutterhead

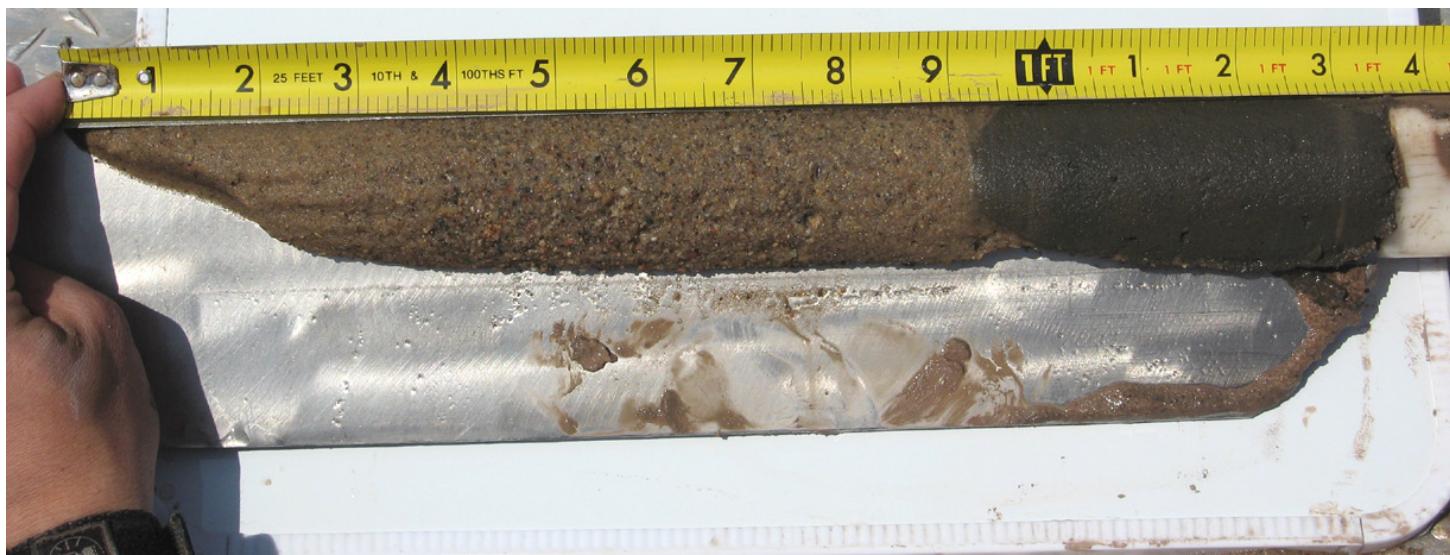
Caps monitoring & maintenance

- Cores
- Geophysical surveys
- 30+ years
