Fox River PCB Cleanup Completion

Fox River Cleanup Complete

- 40 miles of river
- Dredging/Disposal - 6.5 million yards
- Capping - 1000 acres
- Cost: \$1 billion - paid by “Responsible Parties”
- Team effort: Companies, EPA, WDNR, Fish & Wildlife, Tribes

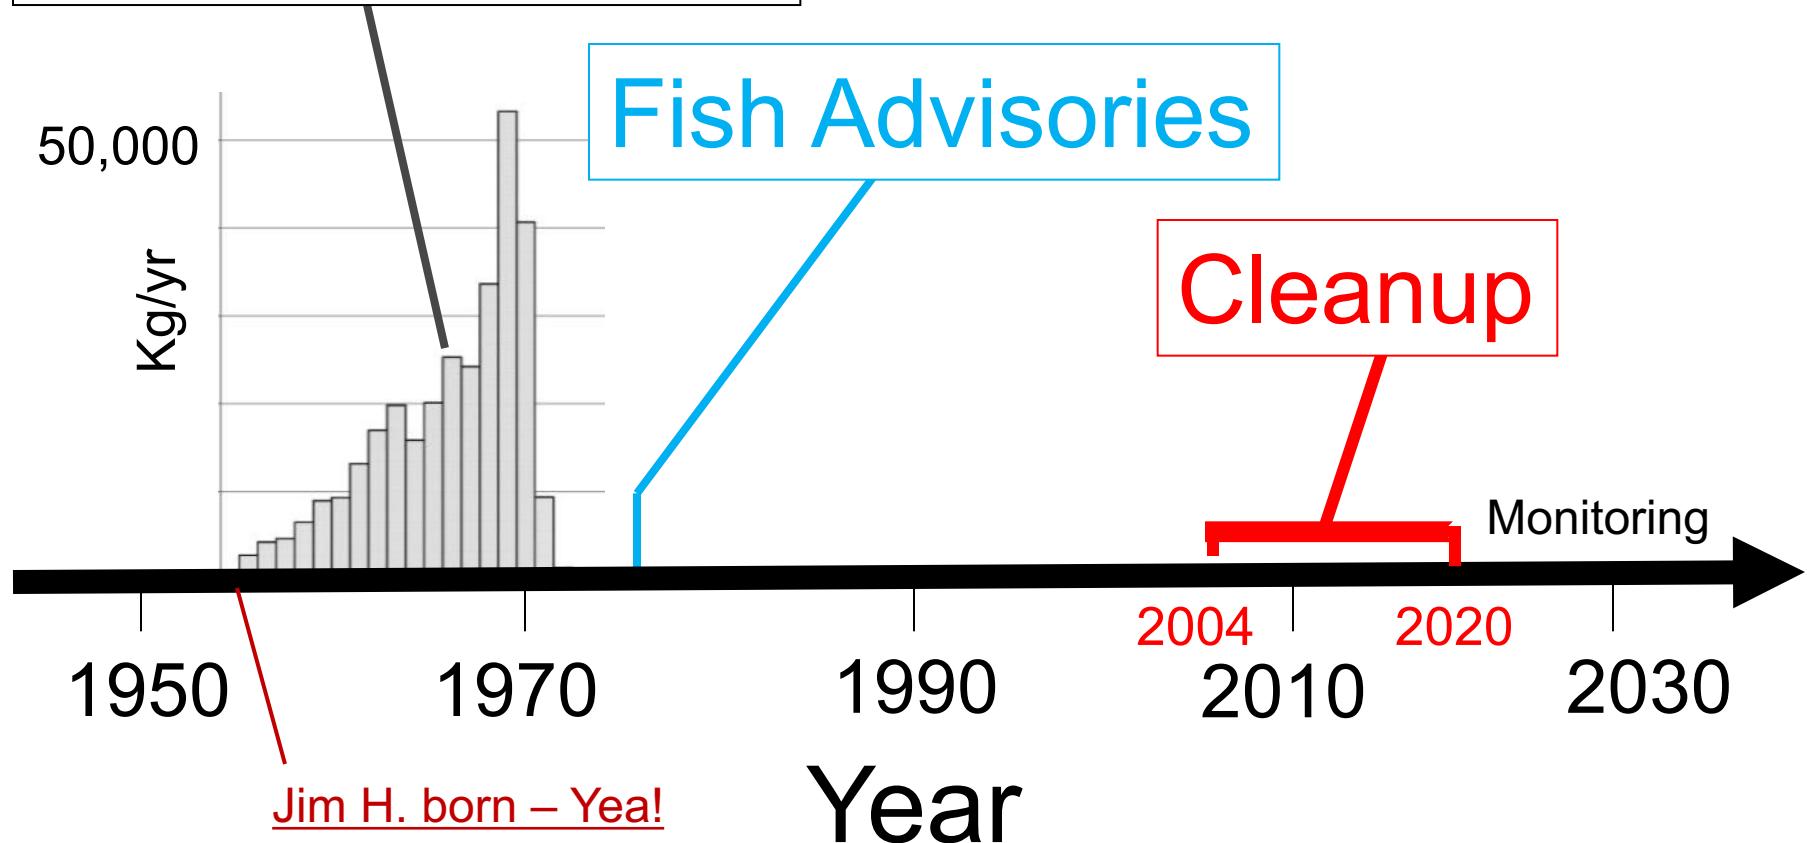
PCB Discharges*

* From: WDNR, 1999, Technical Memorandum 2d.

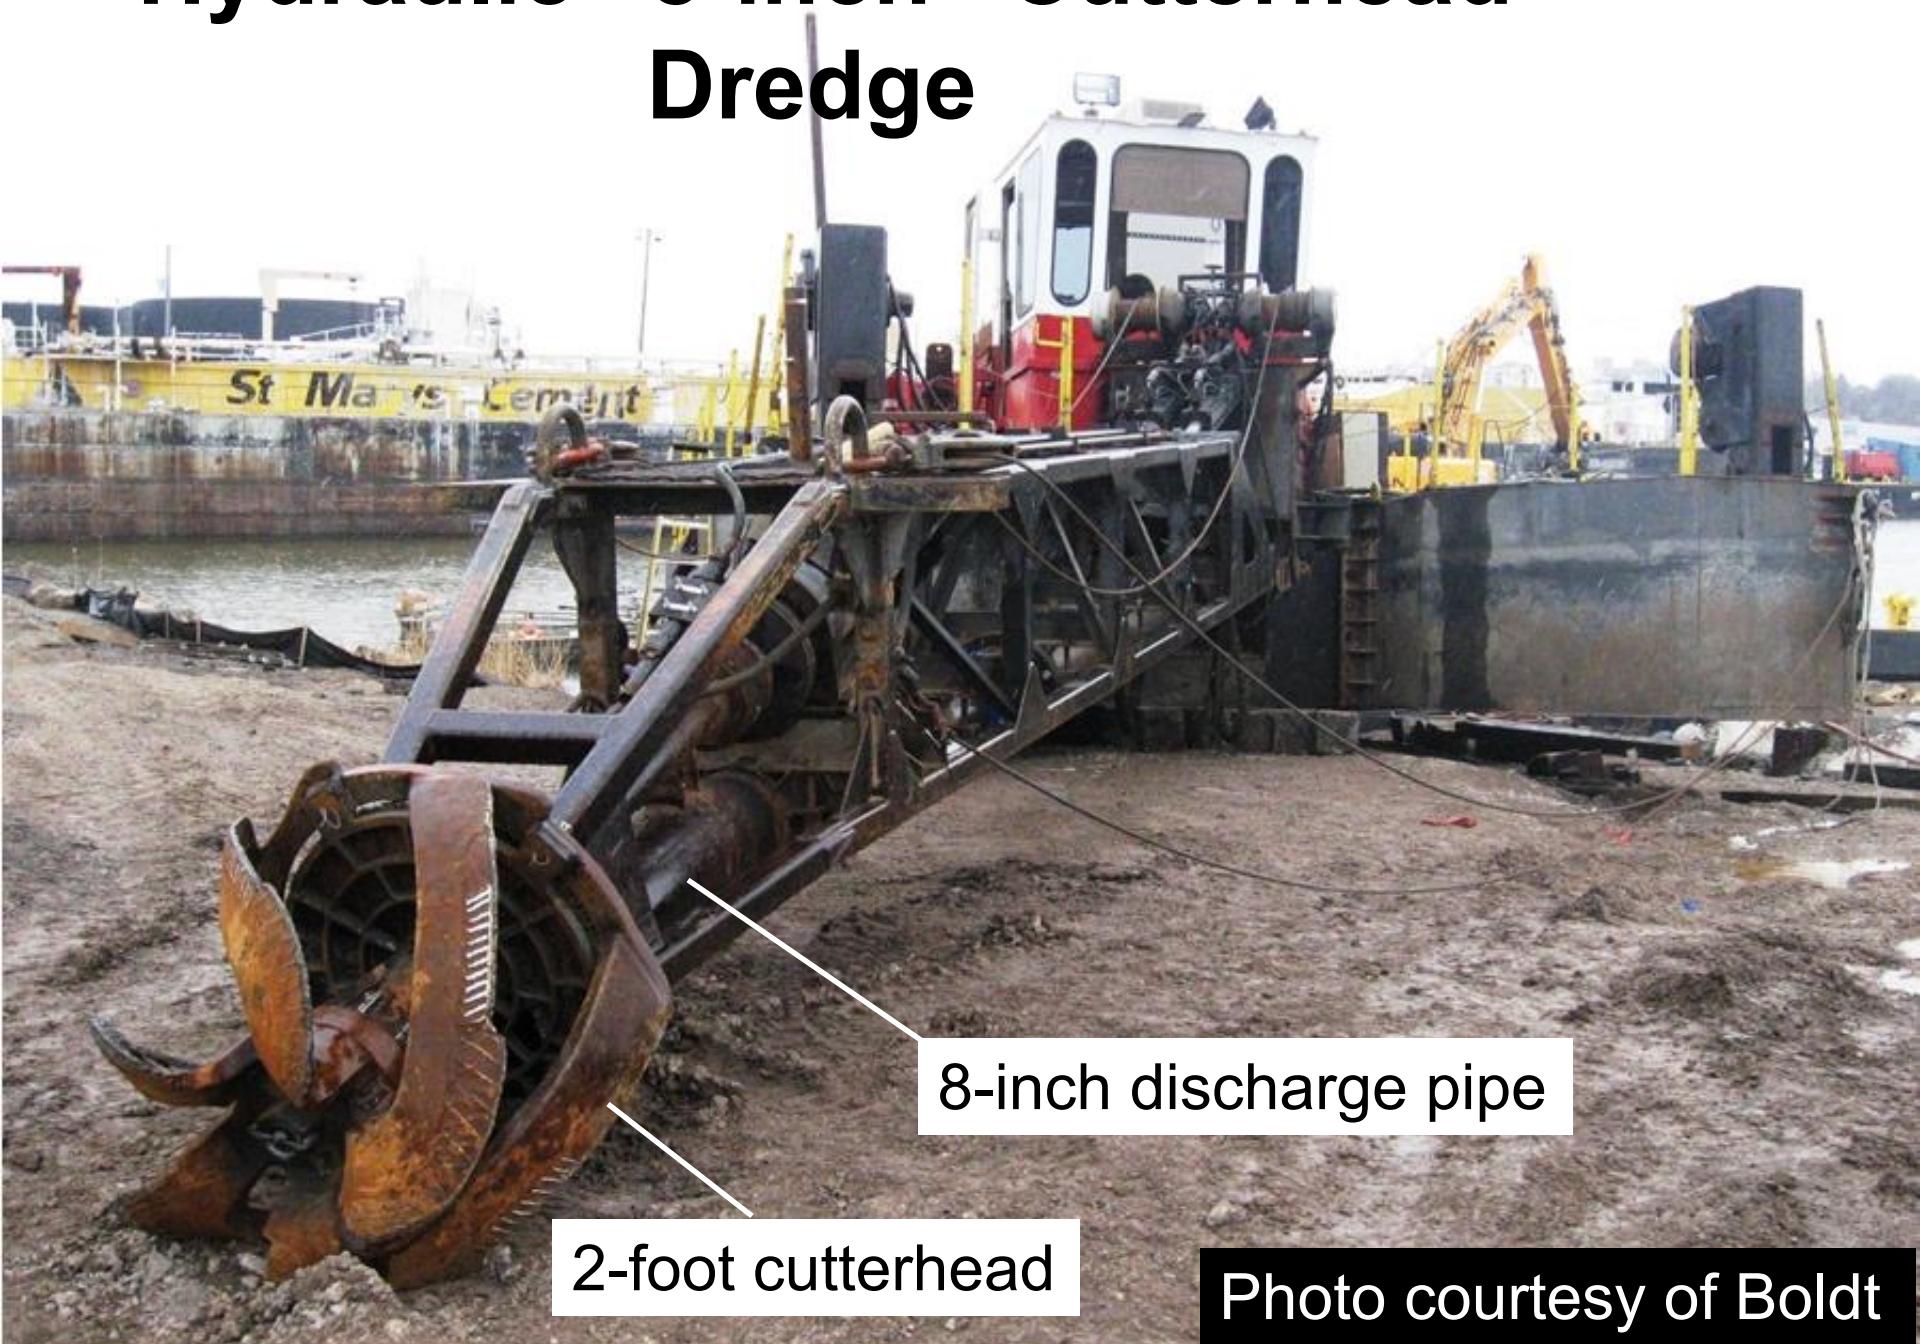
Hydraulic “8-inch” Cutterhead Dredge

| Discharge pipe size | Cutter head size | Optimum “cut” thickness | Daily production |
| 8 inches | 24 inches | 1.5 feet | 400 – 1000 cy |
| 12 inches | 36 inches | 1.5 – 3.5 feet | 3,100 – 3,400 cy |

Downstream annual production: ~500,000 cubic yards
(Upstream: 100,000 – 250,000 cubic yards)

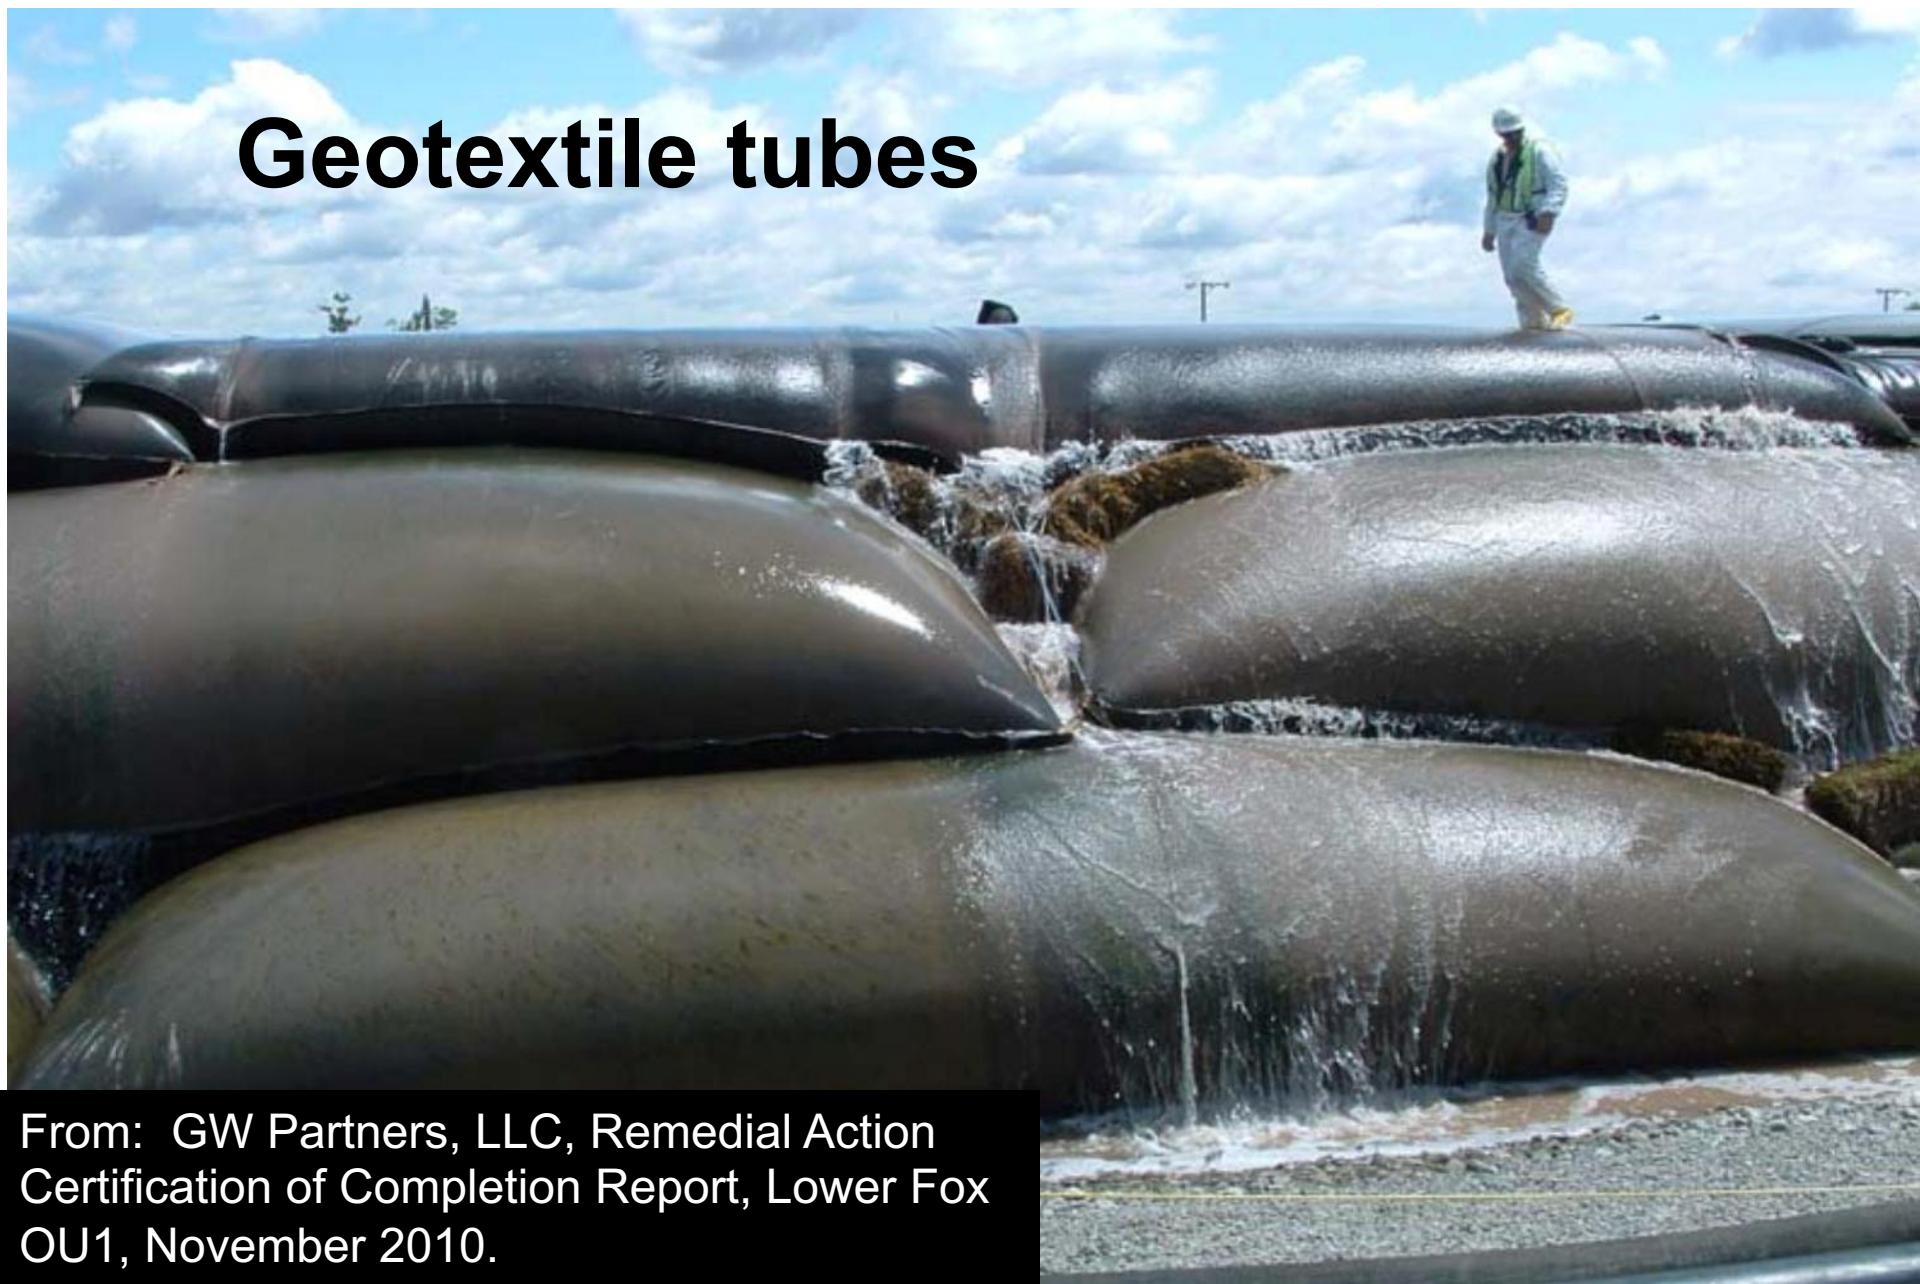
Geotextile tubes

Upstream Dewatering

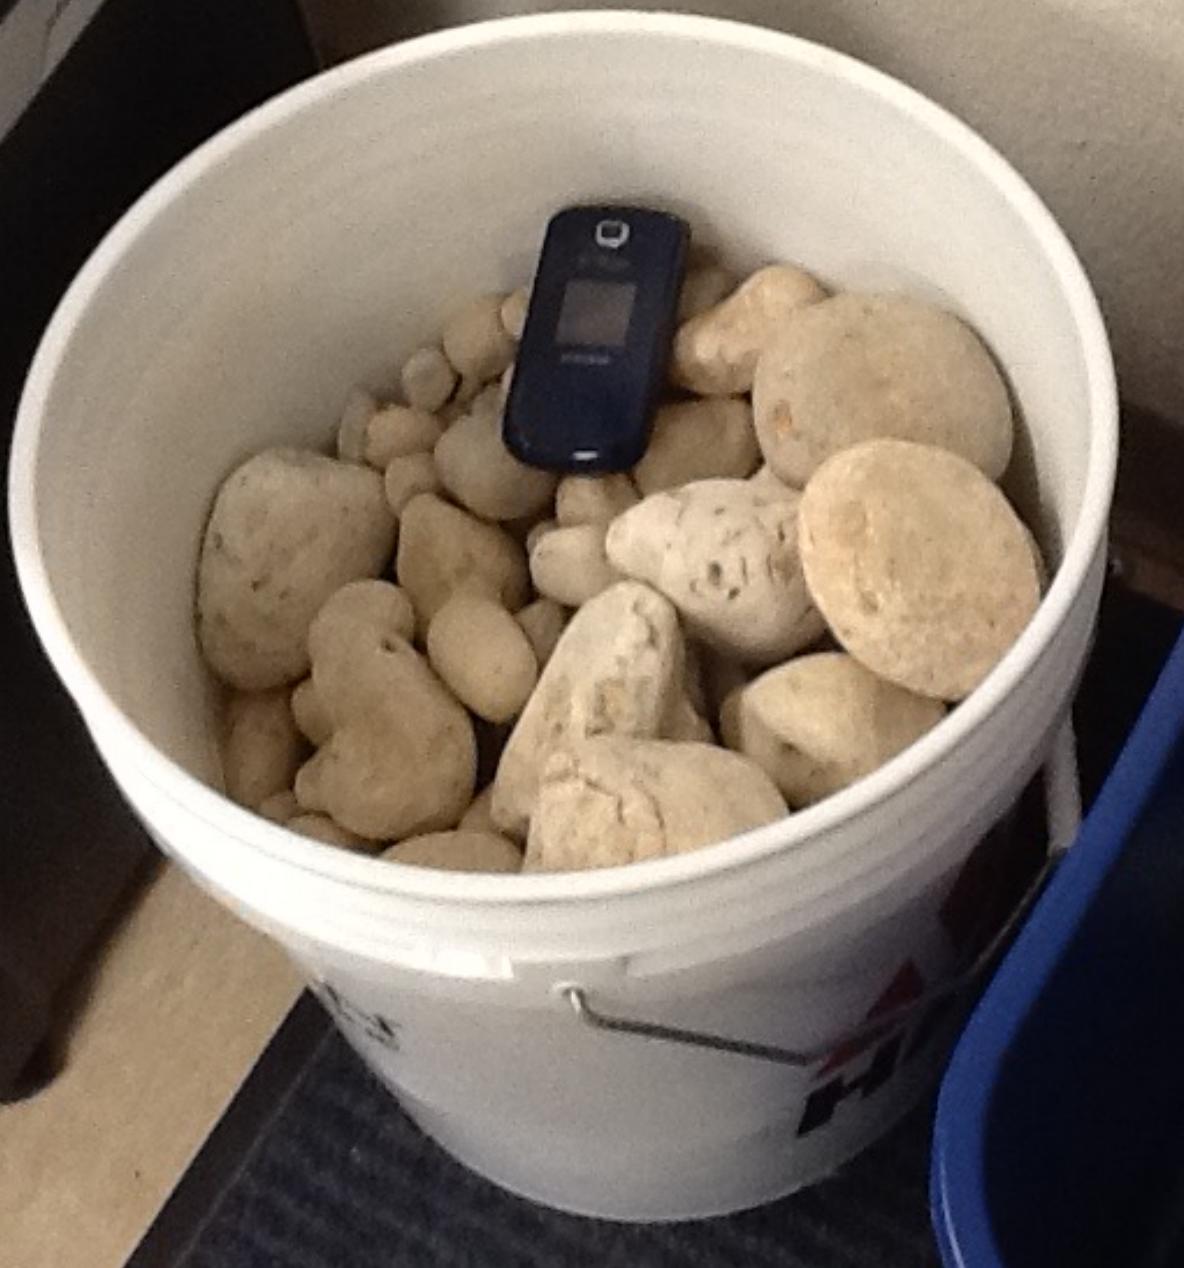
Caps

1-RA-08-SP-A-4 N-6"-RS

Clean
Sand Cap

Contaminated
Sediment

Cap Armor Stone
